**FRENCH RIVER BASIN
DUDLEY, MASSACHUSETTS**

**PETER POND DAM
MA 00112**

PHASE I INSPECTION REPORT NATIONAL DAM INSPECTION PROGRAM

AUGUST, 1978

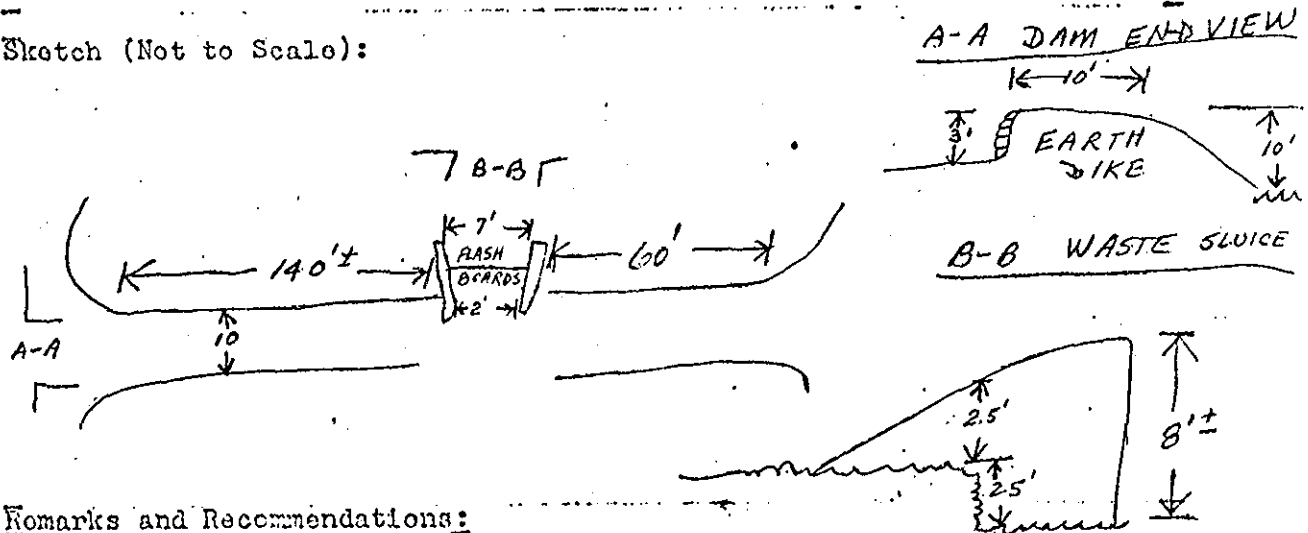
Sketch (Not to Scale):

General Description of Dam and Discharge Control: EARTH - DRY WALL
WASTE GATE 2 1/2 X 1' REMOVED. WATER CONTROLLED
BY FLASH BOARDS 2" X 12" X 2.5' HIGH.
